## ADDINOL - Highlights

### Addinol Eco Gear 460M performs under the largest practical test largest bucket wheel excavator in the world.

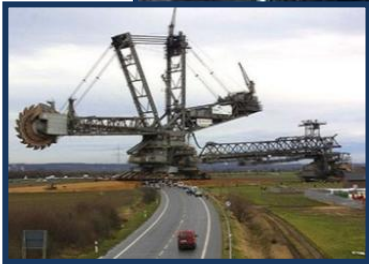
Bucket-wheel excavators are among the largest and therefore most impressive machines. Bucket-wheel excavator "288" was built by Krupp Industry Technologies in 1978 and is in use in the open pit Garzweiler of the RWE Power AG. This excavator and its 7 siblings are the largest excavators in the world. Because of its sheer size, the gear of the bucket wheel drive has respective dimensions. In Autumn 2006 it was changed to a high performance gear oil of Addinol Lube Oil GmbH. So far, the gear oil masters its practical test without any problems.

The bucket wheel excavator mines 240,000 tons of brown coal every day. It weighs more than 13,000 tonnes. With 240 metres it is as long as two and a half football fields. The height amounts to 96 metres. The bucket-wheel itself has a diameter of 21.6 metres – roughly the height of an eight-storey apartment block. 18 buckets hold more than 5m<sup>3</sup> each, and the large main drive of the bucket-wheel is lubricated with 2,800 litres gear oil.

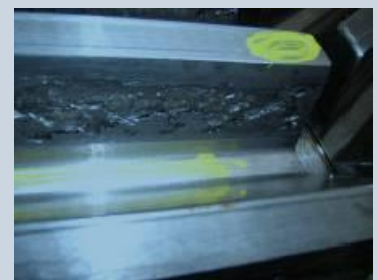
Typical condition of the tooth flanks in  
September 2006  
Sharp edged pitting on tooth flanks

The loads on the gear are enormous: it is exposed to pushes and vibrations as well as dirt, coal dust, varying temperatures and humidity. Damage seems to be unavoidable. During a large inspection of the gear in September 2006, evident damages were discovered on the gear teeth. The obvious thing to do was to change the lubricant. After detailed consultations between the RWE Power AG and the application technology of the ADDINOL Lube Oil GmbH, the gear was changed to ADDINOL Eco Gear 460M.

Whether the lubricant could prove the ascribed effect also in the gear of bucket wheel excavator 288 was checked during the next inspection in spring 2007. The condition of the tooth flanks had not worsened. The high-performance gear oil had passed its first practical test. The sharp edges of the old pitting had been rounded off; smoothening of the pitting had already started.
